## CANADIAN METAL-AD CORPORATION

# SERVICE BULLETIN

## End Fittings with Seal Face Damages

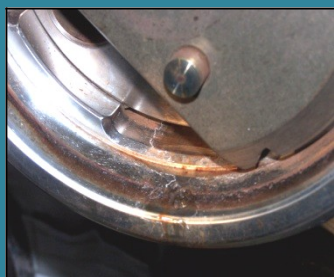
Deep pitting and corrosion damage (.025" deep) caused major refueling problems.

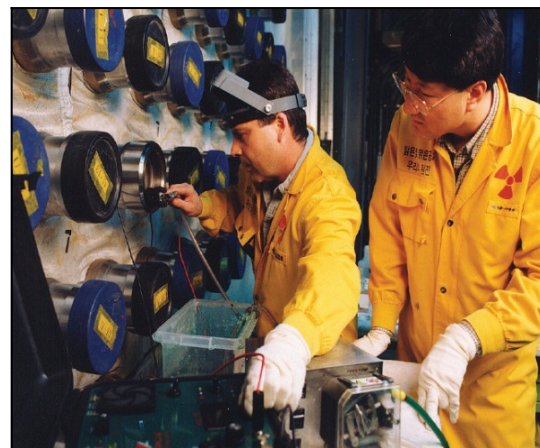
During an outage, severe impact damage was discovered on the Seal Face of an End Fitting; thus, highly rendering a potential for leakage during the refueling process. Many possible repair methods were considered. Brush Plating was chosen for its reliable bonding strength and hard porosity free deposit - in addition, very little heat is generated throughout the deposition process.

**Canadian Metal-Ad Corporation** was contacted about this problem in South Korea. We had one of our technicians on-site in Wolsong 2, South Korea. Our technician spent 3 days on-site; however, the actual repair time was less than 4 hours, minimizing the operator's exposure to the high fields associated with working on the reactor face. Twice, Korea Hydro encountered damage of this type, and in both cases, CMC was chosen to do the repair.

Repair of E-Face surface prior to the start up at Wolsong 2, South Korea (2002).
