## CANADIAN METAL-AD CORPORATION

# SERVICE BULLETIN

## Fueling Machine Repairs

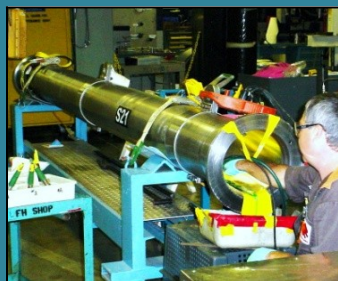
Score damage on I.D. of the RAM barrel housing being repaired with Brush Nickel Plating.

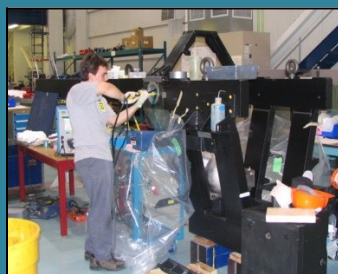
Brush Plating repair done on an oversized bearing fit on an FM Frame unit.

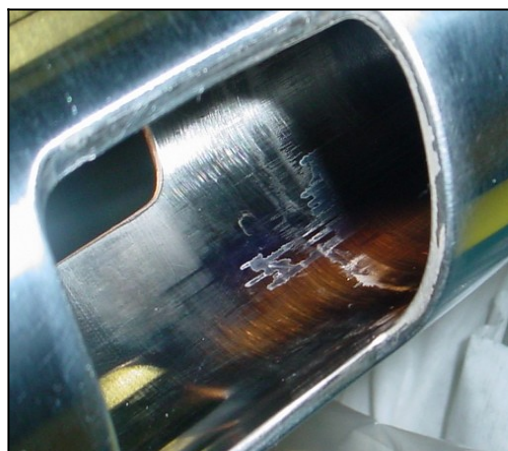
Shown below is a Latch Tube which has sustained scoring, pitting and erosion damages at the cleveite seal area. Using specifically designed plating and turning equipment, damages of this nature are permanently repaired in a few days. This represents a huge savings when compared to the replacement cost of a new set of tubes. The program has been so successful that Pickering OPG has now included this Brush Plating repair procedure as routine on every RAM overhaul.

Pitting damages on ID of Latch Tube caused high leak rates at the cleveite seal.

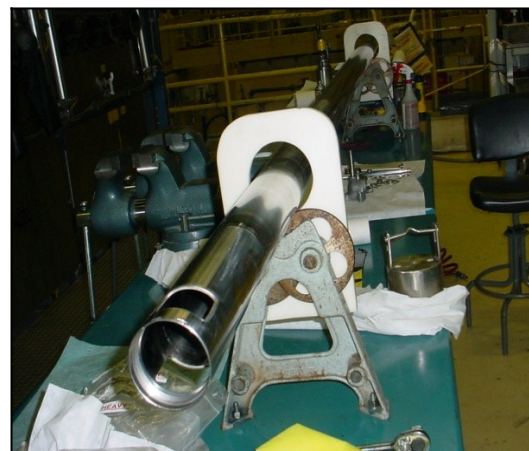
CMC's unique set-ups have been developed for the repairs on all types of Ram Tubes.
