**CANADIAN METAL-AD  
CORPORATION**

# SERVICE BULLETIN

## PHT Motor Shaft Repair

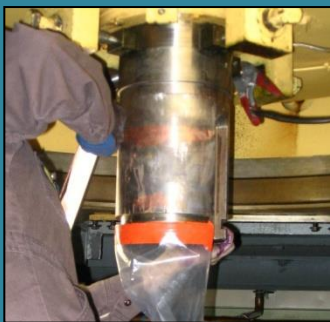
Shaft is selectively masked and copper is plated only on the low and pitted areas.

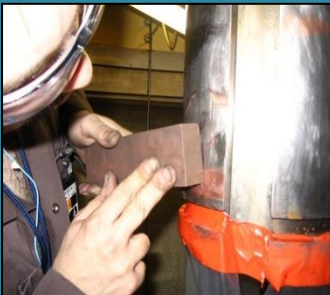
Our skilled technicians hand-dressed the built up copper and blend with the shaft.

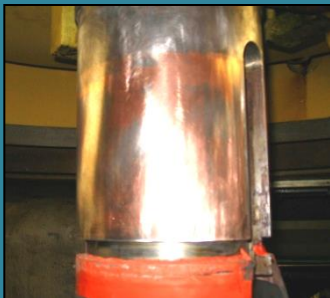
Copper is left in the affected area. The surface is now ready for a hard nickel coating.

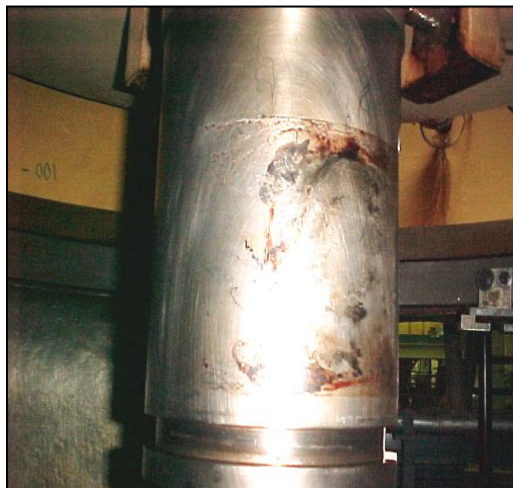
Severe fretting and pitting damages under the coupling caused vibrations to the pump at high speeds.

Disassembly of large components can be avoided and repairs can be made right on-site. Below is a PHT motor shaft that has sustained severe corrosion and fretting damages (causing an unacceptable amount of vibration) at one of the Bruce Nuclear Power Plant reactor units. The removal and replacement of the motor would have been very labour intensive, time consuming, and possibly delayed the re-start of the unit. The corrosion was filled with copper and the shaft was re-sized using a hard nickel coating. The repair took our two technicians a total of three days to complete and only required the removal of the coupling.

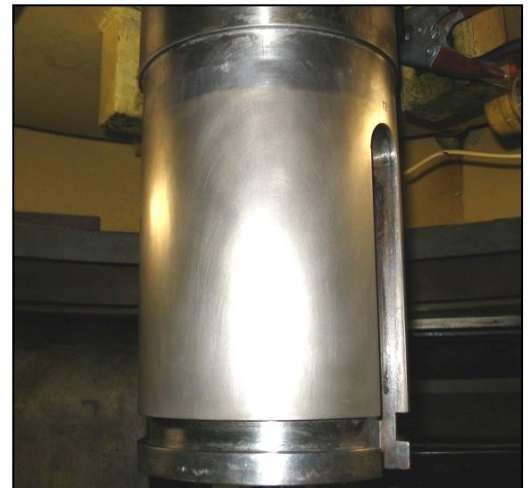
A final coating of nickel is deposited over the shaft to protect both the copper-filled and the softer base metal.
